Laboratory report

McNetiq BV
RM19056 Mcnetiq
B.Hoppener
23-05-2019

To determine the corrosion resistance of a coated magnet bas Gravendeel of Mcnetiq has ordered M2LAB to perform laboratory tests.

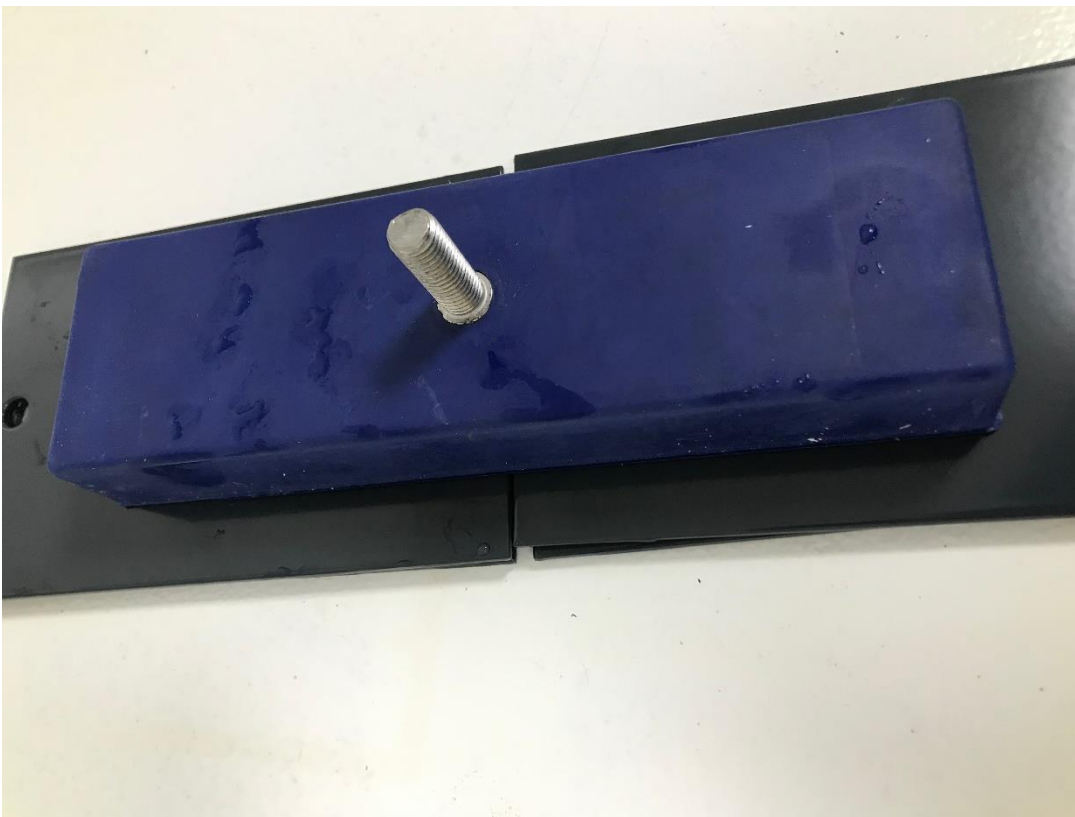
1 magnet with blue coating

Magnet has been mounted on 4 corrosion resitant panels to minimize the magnetic field around the sample in the test chamber.

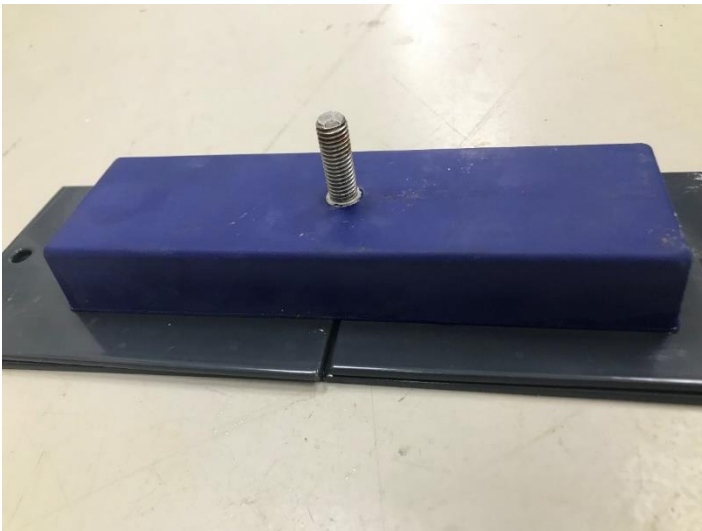
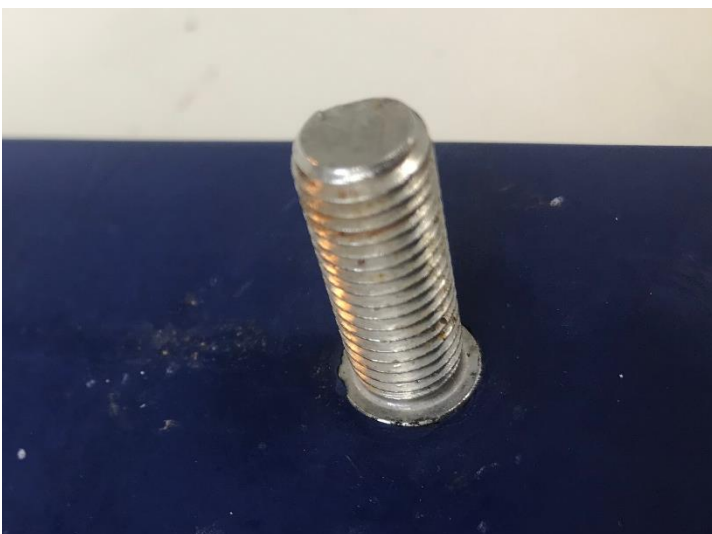
Sample after test

The coated surface of the tested sample doesn't show any sign of corrosion.
 The bolt on top of the sample shows corrosion of class Ri1 according to ISO 4628.

- the coated area of the tested sample doesn't show any sign of corrosion.
- the uncoated bolt shows corrosion with a severity of Ri1
